## **Troubleshooting: Low Vacuum Fault**

**Issue: The Reclaim system is displaying a low/No Vacuum Fault code. The Vacuum switch does not see enough vacuum from the Mazzei Eductor to run the Ozone Generators. As water flows through the reclaim system, it creates a vacuum to draw in the ozone. If it fails to do so, the Reclaim system will stop ozone production.**

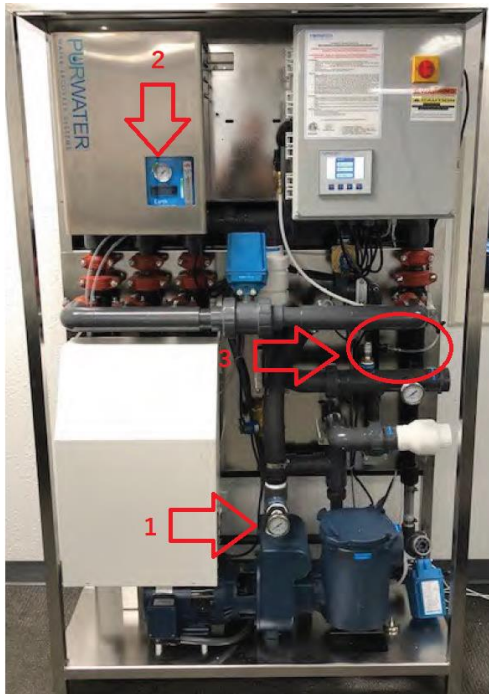
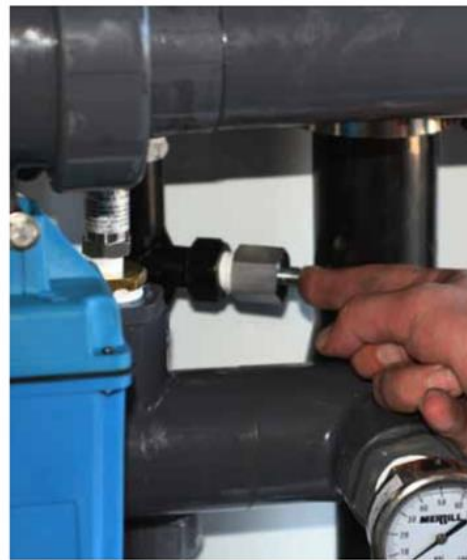
1. Check the Gauges on the Reclaim system.
  - A. Verify the water pump pressure on the gauge when the pump is on. The Gauge should read 15psi or higher attached. This gage is highlighted by arrow 1.
  - B. The ozone generator pressure should be 8psi. This is highlighted by arrow 2.
2. Check to see if suction present when went the clear hose is removed from the Mazzei Educator when the pump is on. This hose is highlighted by arrow 3 and the second picture.

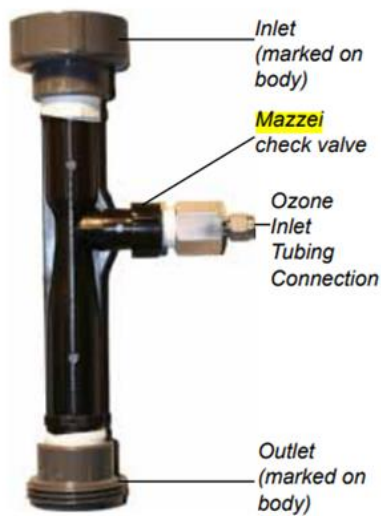
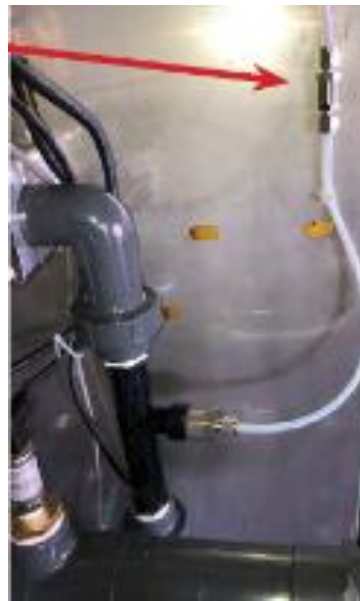
3. Clean the Mazzei Eductor.
  - A. Place the Reclaim system into hand mode through the HMI.
  - B. Clean the black plastic pipe and the clear tubing from the Mazzei check valve to the stainless-steel check ball valve and the tubing from the stainless-steel check ball valve to the Electrical panel using a pipe cleaner.
  - C. Clean the Mazzei check valve and ozone inlet tubing connection.

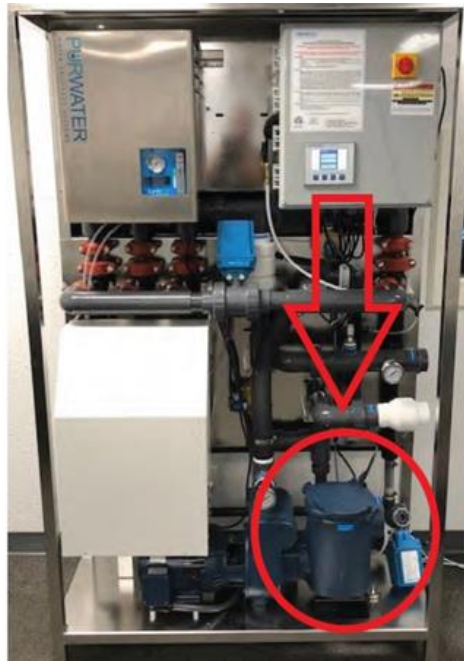
4. Clean out the strainer basket.
